Manhole Inspection Summary

Manhole # S25I__003MH

Insp Date: **9/6/07 9:07 AM**

Location Address: **1302 HOLLINS ST**

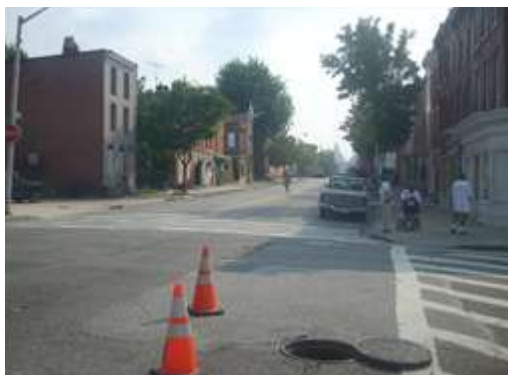
Location View

CONCRETE AROUND LID IS
DETERIORATING MAY CAUSE
PONDING

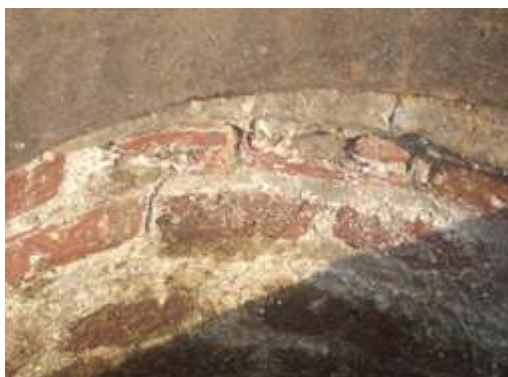
Defect 5

Condition: ☐ Sound ☐ Cracked ☐ Root Intrusion ☐ Loose Brick ☒ **Deteriorated**

DETERIORATED CORBEL AND
CHIMNEY

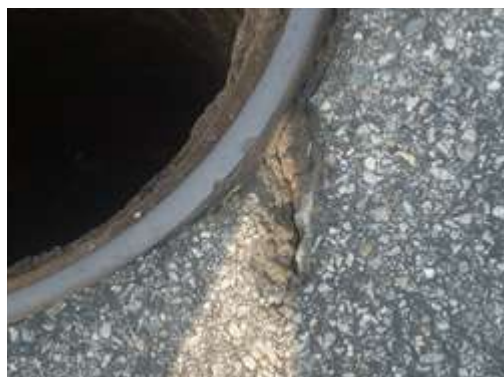
Defect 4

DETERIORATED CONCRETE

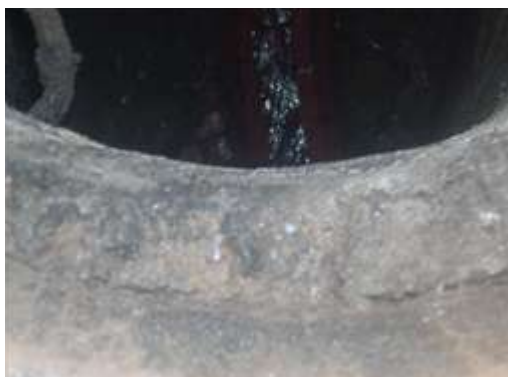
Defect 3

Frame Offset: **3** (in.) Condition: ☒ Sound ☐ Cracked ☐ Leaks

FRAME OFFSET

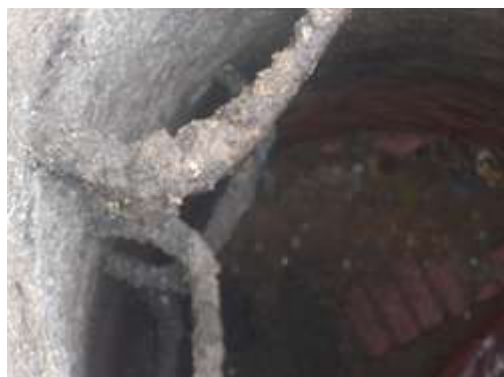
Defect 2

Steps Count: **4** Missing: **0** ☒ **Corroded**

CORRODED STEPS

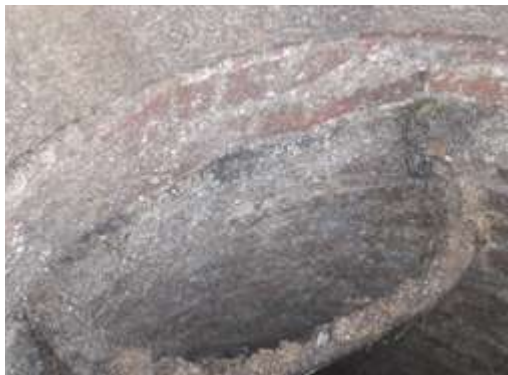
Defect 1

Surcharge ☒ **Evidence Of Surcharge** Depth: **6** (ft.) ☐ Active Surcharge Present

SURCHARGE EVIDENCE ON STEPS
AND WALL

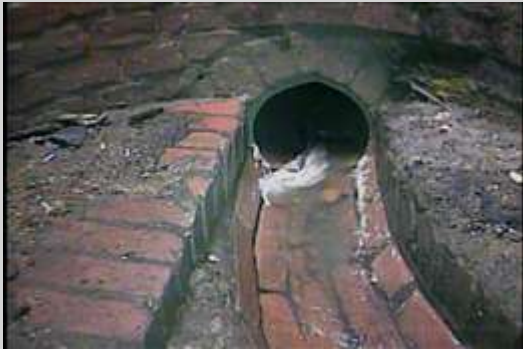
12 O'Clock Outflow

Pipe Height: **8.4** (in.) Rod and Bar (Angled)
Pipe Material: **Clay** ☐ Pipe Lined
Invert Depth: **8.78** (ft.) Flow Characteristics: **Slow**
Deposits: ☐ None ☐ Mud ☐ Sludge ☒ **Debris** ☐ Grease
Silt Depth: **2** (in.) Deposits Extent: **Light**
Infiltration: **None** Pipe Seal Cond: **Sound**

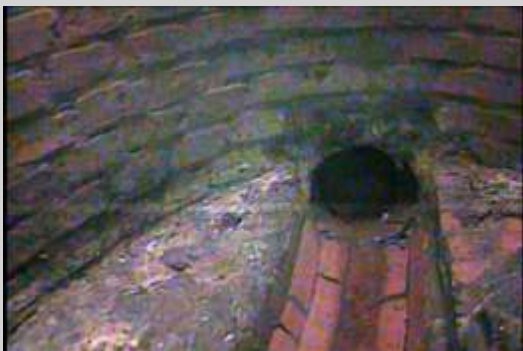
4 O'Clock Inflow

Pipe Height: **8.4** (in.) Rod and Bar (Angled)
Pipe Material: **Clay** ☐ Pipe Lined
Invert Depth: **8.76** (ft.) Flow Characteristics: **Slow**
Deposits: ☒ **None** ☐ Mud ☐ Sludge ☐ Debris ☐ Grease
Silt Depth: (in.) Deposits Extent:
Infiltration: **None** Pipe Seal Cond: **Sound**
